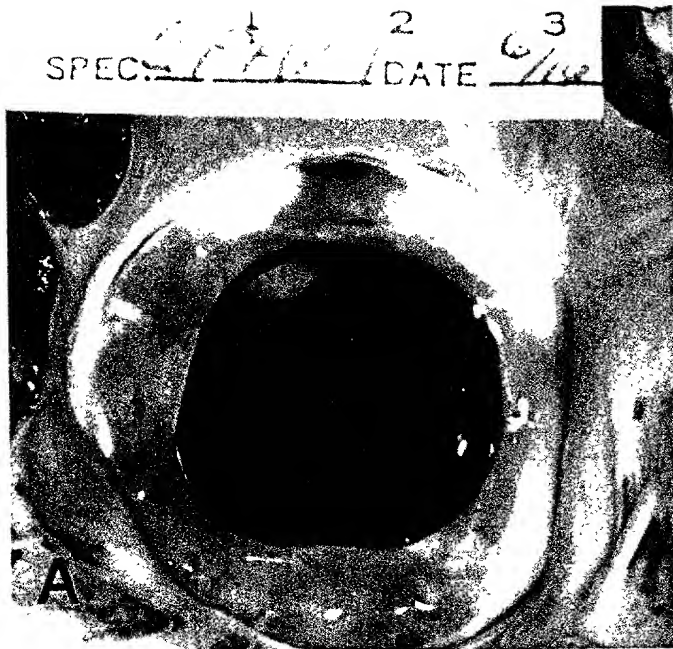
Figure 3. Color photograph of an explanted untreated control heart valve (CAP-1) after 181 days in a juvenile sheep implant study different from the study involving the valves of Figures 4-7.
